### FINAL REPORT JULY 2007

### REPORT NO. 06-04E

EVALUATION TRANSPORTABILITY TESTING OF THE JOINT MODULAR INTERMODAL PLATFORM (JMIP) UNIT #4 TP-94-01, "TRANSPORTABILITY TESTING PROCEDURES"

### **REPORT NO. 06-04E**

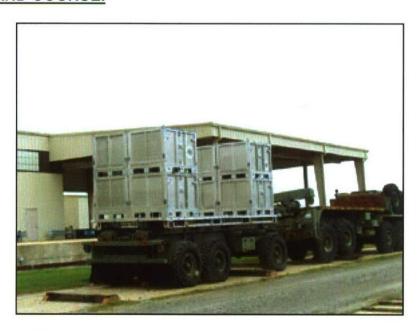
Photo 2. Hazard Course Testing of the JMIP

- 1. Figure 6 lists the average speeds of the test load through the Hazard Course.
- 2. The JMIP was transported on the PLS trailer.
- 3. The JMIP had to be craned onto the PLS trailer. The JMIP, as currently designed, cannot be rolled back on the PLS trailer using the vehicle load handling system due to the outward location of the rollers. The outward roller location prevents the JMIP from staying properly aligned when rolled back onto the PLS trailer. Additionally, the top JMICs had to be removed to prevent interference with the slings when loading/unloading the JMIP from the trailer.
- 4. Inspection did not reveal any damage to the JMIP.

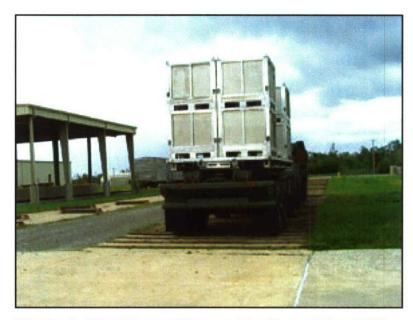
Photo 4. Washboard Course Testing of the JMIP

**Remarks:** Inspection following the Washboard Course revealed no damage to the JMIP.

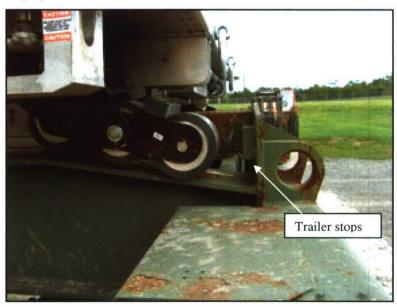
- 1. Throughout testing the JMIP moved forward and aft on the PLS trailer due to the JMIP not properly engaging the trailer stops.
- Following the completion of the testing, the JMIP was difficult to disengage from the PLS trailer. The JMIP had to be manipulated so that the trailer DIN locks would disengage the JMIP DIN locks.

Photo 5. Rollers Not Engaging Trailer Stops

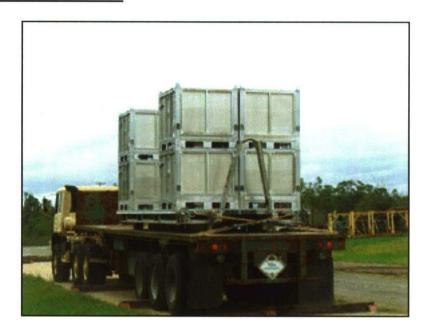
Photo 6. Hazard Course Testing of the JMIP

- 1. Figure 8 lists the average speeds of the test load through the Hazard Course.
- 2. The JMIP was secured directly to the M872 trailer.
- 3. Inspection did not reveal any damage to the JMIP.

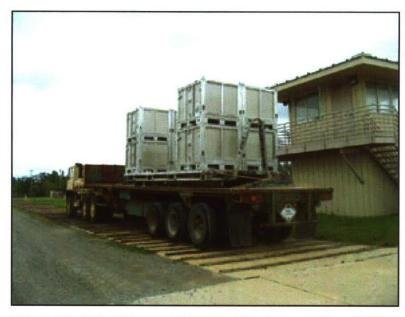
Photo 7. Washboard Course Testing of the JMIP

<u>Remarks</u>: Inspection following the Washboard Course revealed no damage to the JMIP.

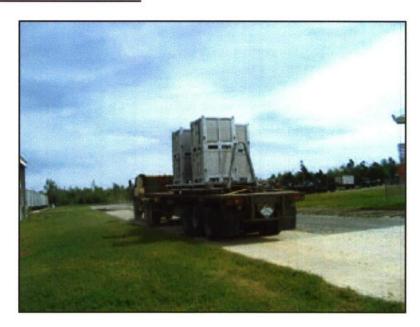
Photo 8. Hazard Course Testing of the JMIP

- 1. Figure 10 lists the average speeds of the test load through the Hazard Course.
- 2. The JMIP was secured directly to the M872 trailer.
- 3. Inspection did not reveal any damage to the JMIP.

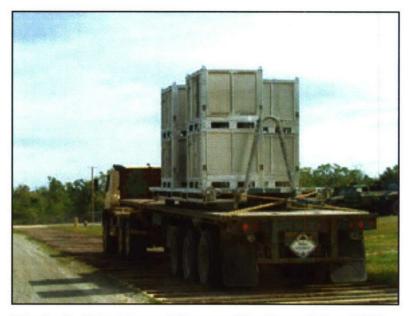
Photo 9. Washboard Course Testing of the JMIP

<u>Remarks</u>: Inspection following the Washboard Course revealed no damage to the JMIP.

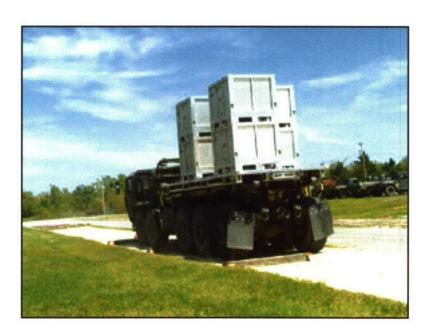
Photo 10. Hazard Course Testing of the JMIP

- 1. Figure 12 lists the average speeds of the test load through the Hazard Course.
- 2. The JMIP was transported on the PLS truck.
- 3. The main JMIP rail on the driver's side front dropped down 0.38 inches.
- 4. The bottom plate on the JMIP rail deformed when contacting the PLS roller. See Photo 12 for deformation and Photo 17 on related delaminating damage.

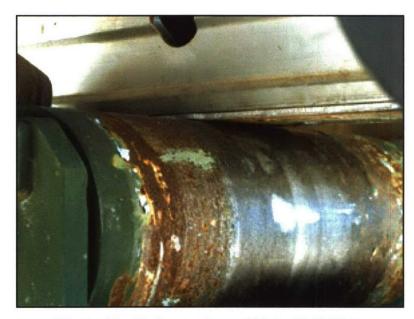
Photo 12. Deformation of Main Rail Plate

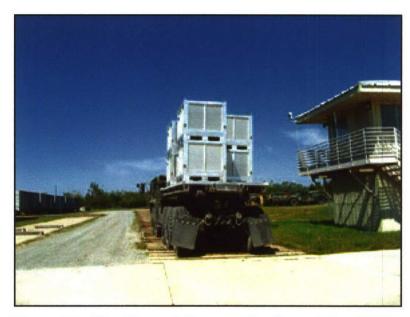
Photo 15. Washboard Course Testing of the JMIP

**Remarks:** Inspection following the Washboard Course revealed no damage to the JMIP.

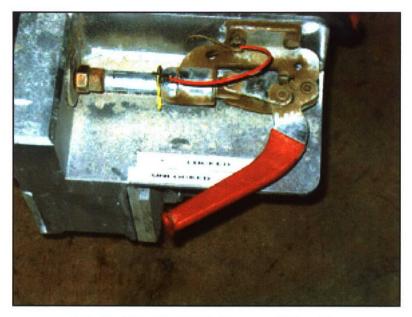
- 1. One (1) handle of the A-Frame PLS position transport pin partially opened. This was most likely caused by the locking nuts moving. The pin remained safely engaged.
- 2. The bottom plate on the main rail was delaminating when loaded onto/off the PLS truck.
- 3. One (1) JMIC locking pin on one (1) side panel had disengaged. The load was still safely secured and retained.

Photo 16. Partially Opened Handle

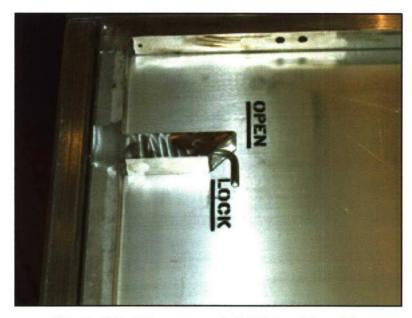
Photo 18. Disengaged JMIC Locking Pin
